USAARL Report No. 95-10

## OH-58 Pilot Display Unit (PDU) Simulated Crash Tests

December 1994

United States Army Aeromedical Research Laboratory  
Fort Rucker, Alabama 36362-0577

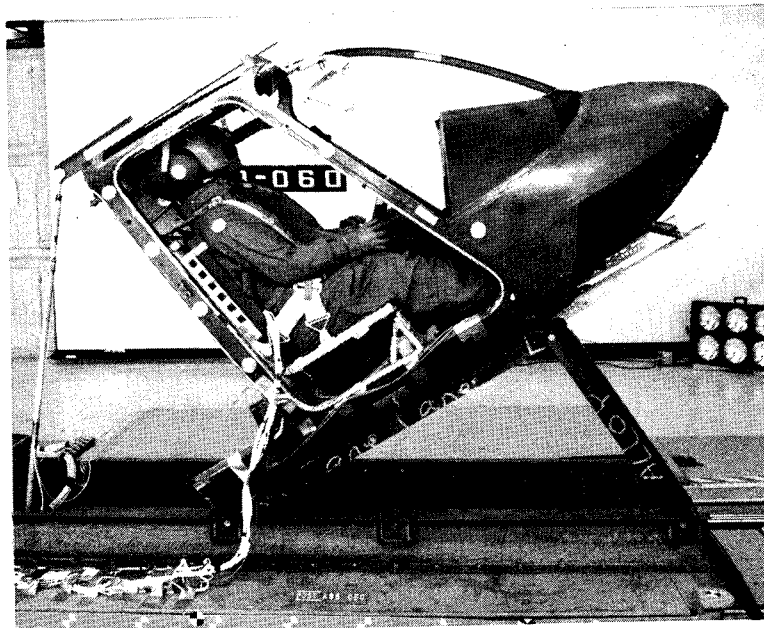
**Figure 5.** Posttest view of no. 88060; note the rearward rotation of helmet after rebound.

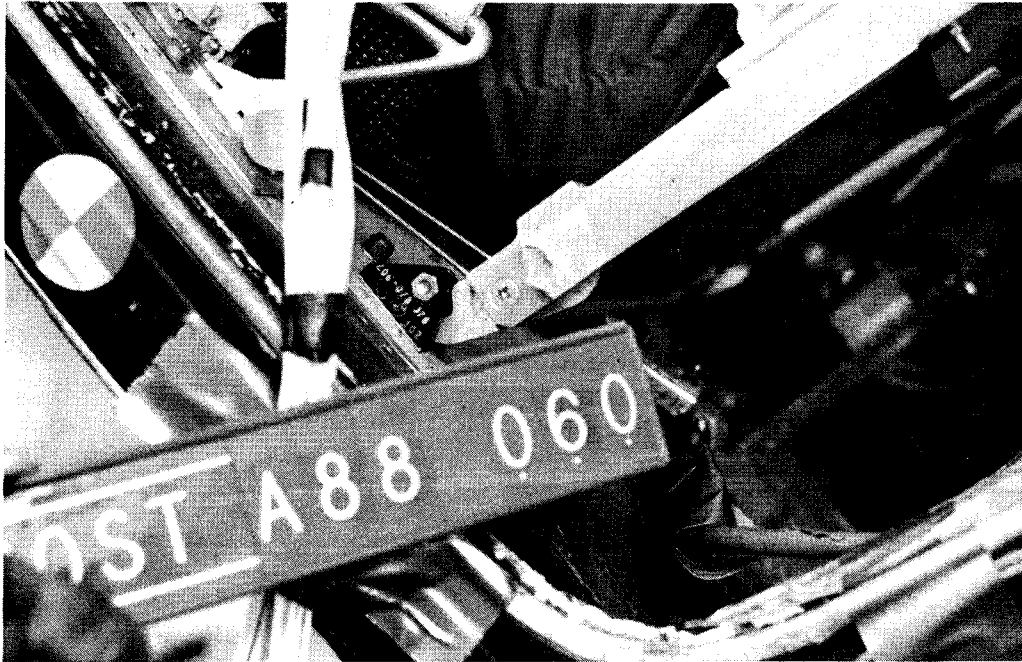
Posttest photos of test 88060 in Figures 4 through 9 show: (a) rotation of helmet rearward on right dummy, but not the left dummy, even though both have equal size 50th percentile heads; the difference may be due to the lack of neck flesh on the Hybrid II (50th percentile) dummy; and (b) the left seat crashworthy seat pan sustained enough downward force from the dummy's buttocks to move the pan down 0.6 inch, and to move the right seat down by 0.3 inch. This was a surprise since the impact vector was 15 G forward, and the seat pans stroke at 12 G vertical. The right seat pan was secured with steel straps to prevent movement in subsequent tests.

Figure 8. Seat pan downward displacement of 0.3 inch shown between latch and bulkhead support, right side.

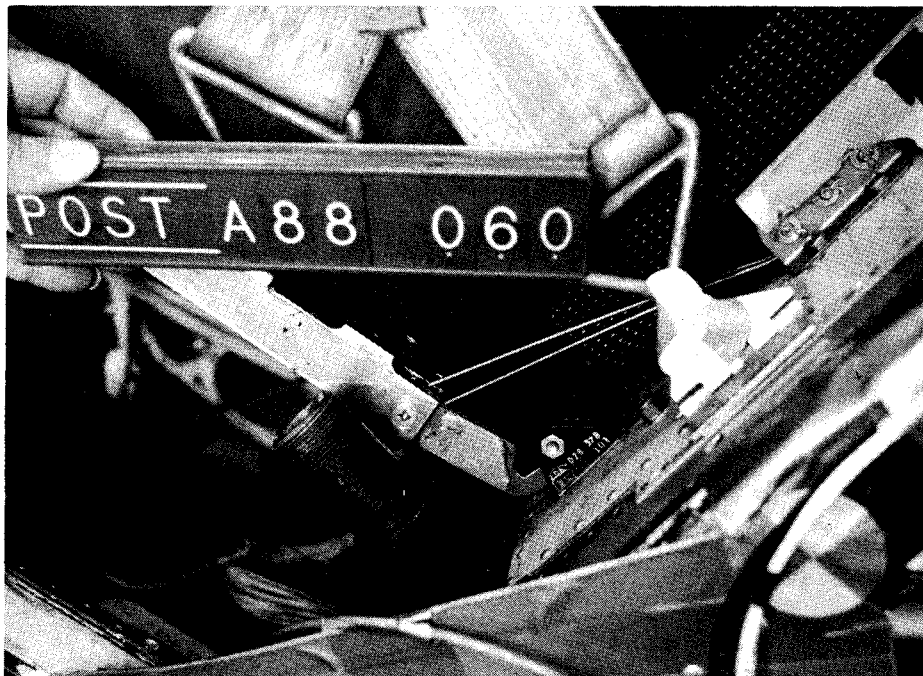
Figure 9. Seat pan downward displacement of 0.6 inch shown between latch and bulkhead support, left side.

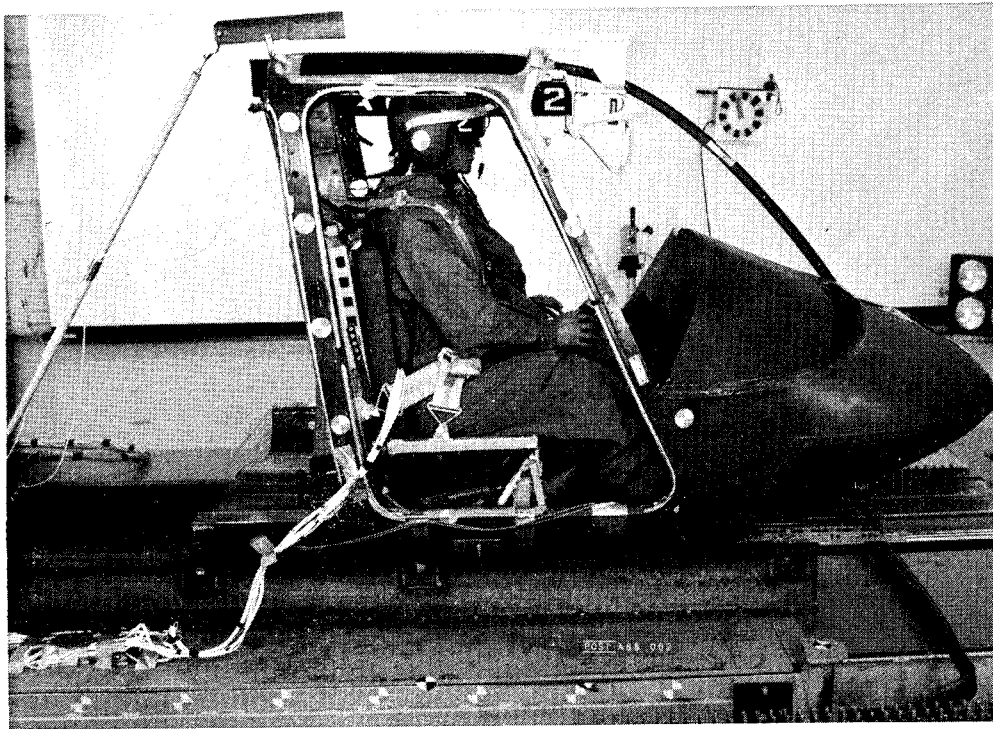
Figure 14. Posttest view of no. 88062; note rebound position of sled about 1 foot from displaced  $\frac{1}{4}$ -inch diameter cable.

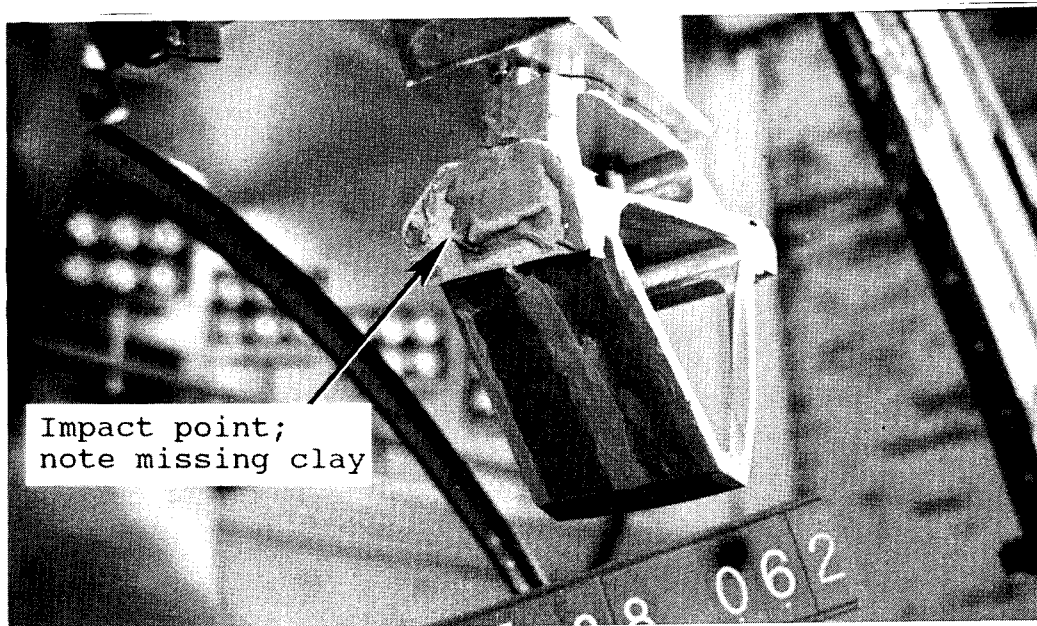
The helmet was replaced after this test due to permanent foam compressive "set" of about 0.05 inch over an area of about 1 square inch in the lower front edge of the foam liner. The foam replacement is required to obtain the full energy-absorbing benefit of the foam liner if impacted again at the same location. The impact location onto the PDU is shown in Figure 15.

Figure 15. Posttest view of no. 88062; note missing clay which was found on helmet of right dummy.

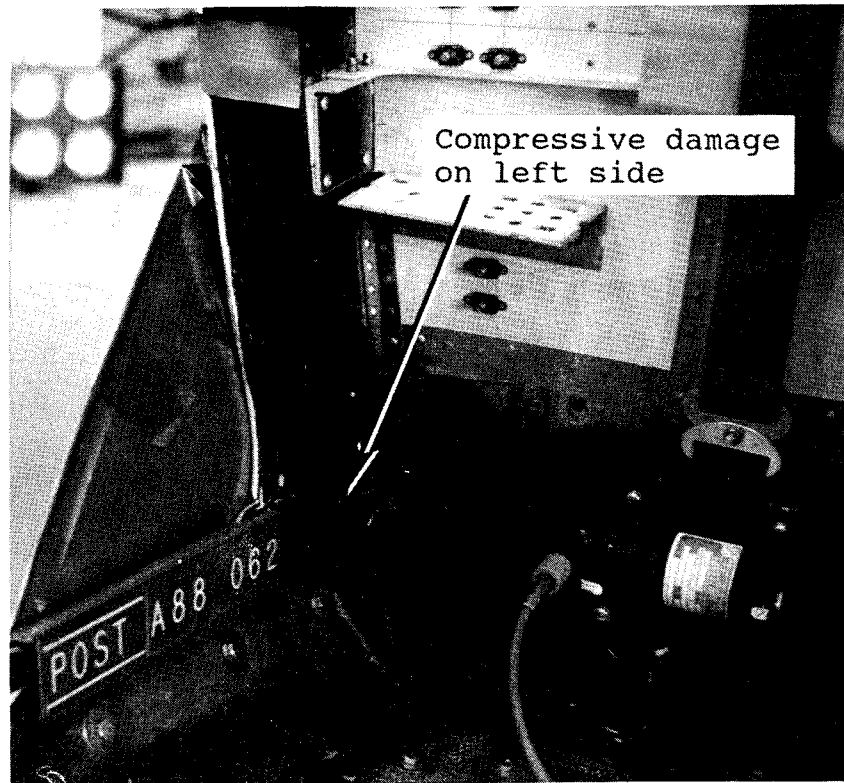
The fuselage station (FS) 73.04 bulkhead was damaged by skin crippling/buckling at the lower outboard edges and at the control "closet" box structure as shown in Figures 16-18. The bulkhead was reinforced prior to the final tests.

Figure 16. Posttest of no. 88062; note buckled "box" section of fuselage station 73.04 bulkhead.

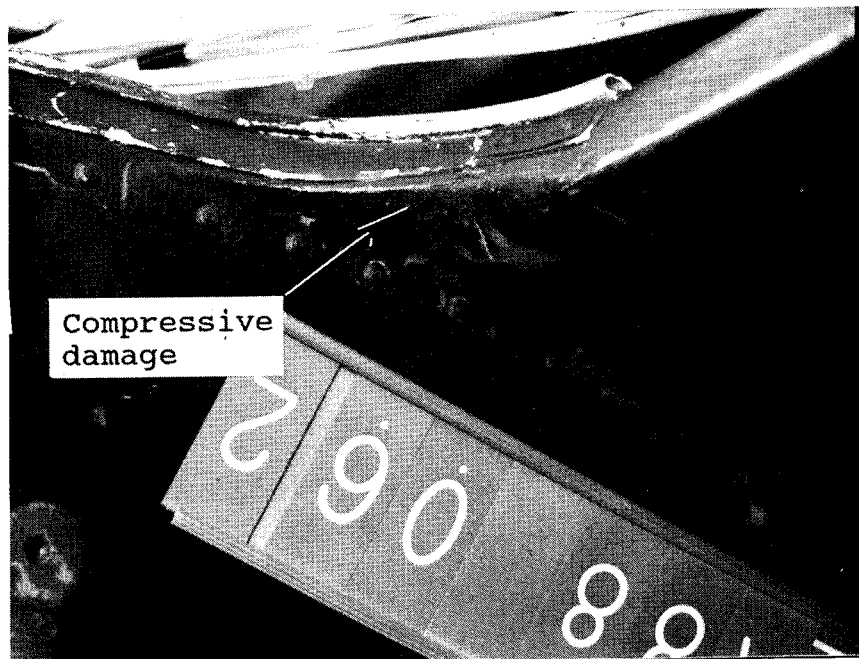
Figure 17. Posttest view of no. 88062; note buckled skin adjacent to "box" section of fuselage station 73.04 bulkhead.

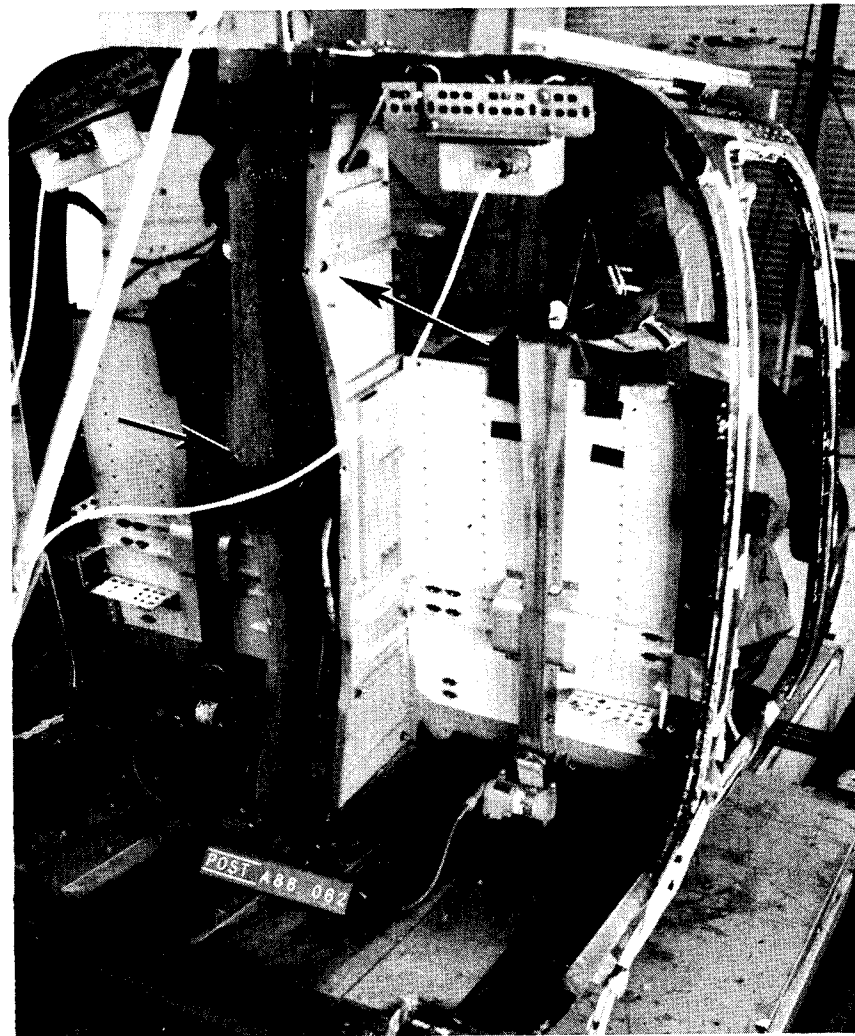
Figure 18. Posttest view of fuselage station 73.04 bulkhead; note buckles in control closet structure by arrows.

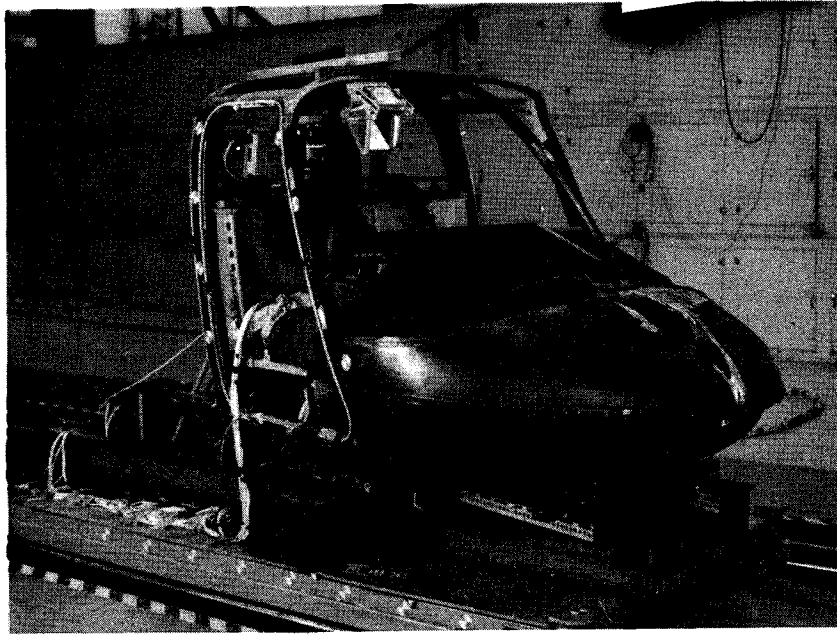
Figure 19. Pretest view of no. 88063; note 15-degree right yaw orientation, and prior damage to nose structure.

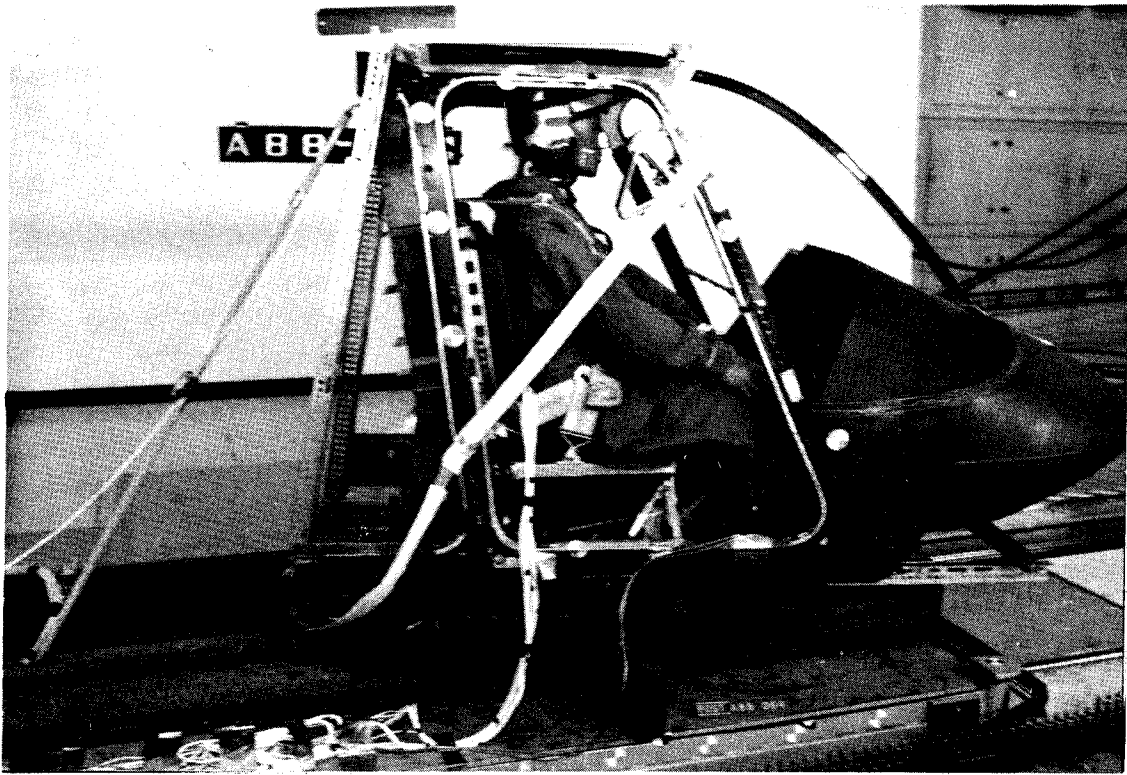
Figure 23. Posttest view of no. 88064; note limp, stretched aluminum diagonal strap, and PDU mount detachment.

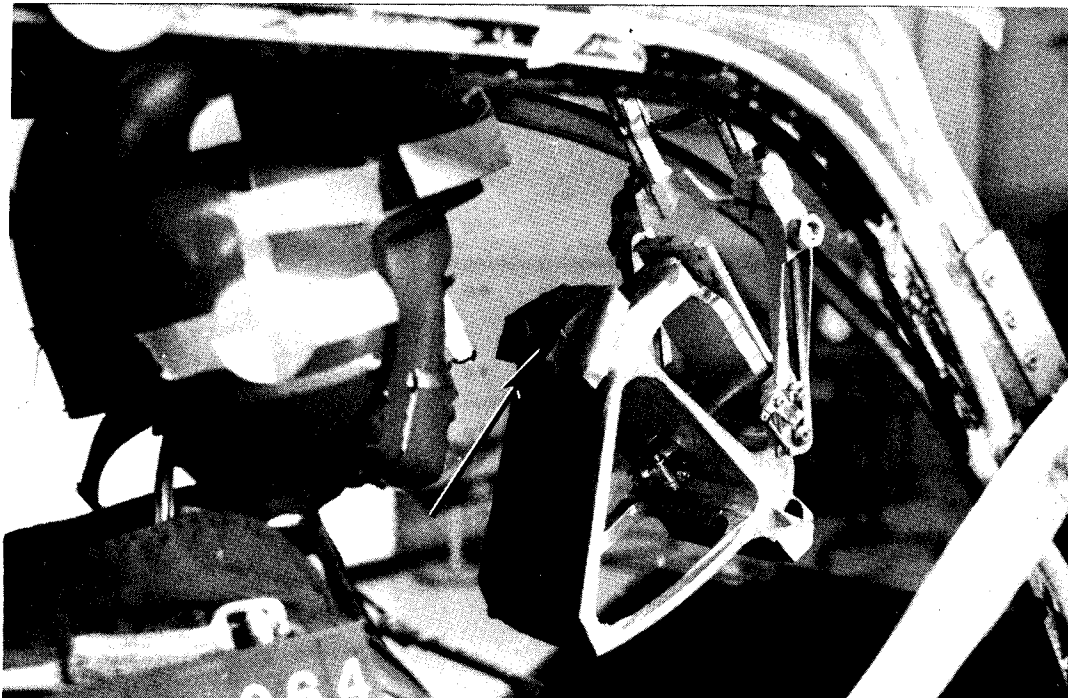
\*\*PDU mount at windshield frame failed partially during rebound, see Fig 24.

Helmet to PDU impact occurred; Figure 31 shows the impact from film analysis. The impact appeared to be severe based on film review since the PDU mount failed at its leading edge rivet attachment to the windshield overhead frame, as depicted in Figures 23, 24, and 26. The impact cracked the helmet visor cover at its center low edge, as shown in Figure 25. The PDU foam also was cracked and the visor cover released the visor knob and visor.

Figure 24. Posttest view of no. 88064; note detached PDU "breakaway" mount and cracked foam at back edge of PDU.

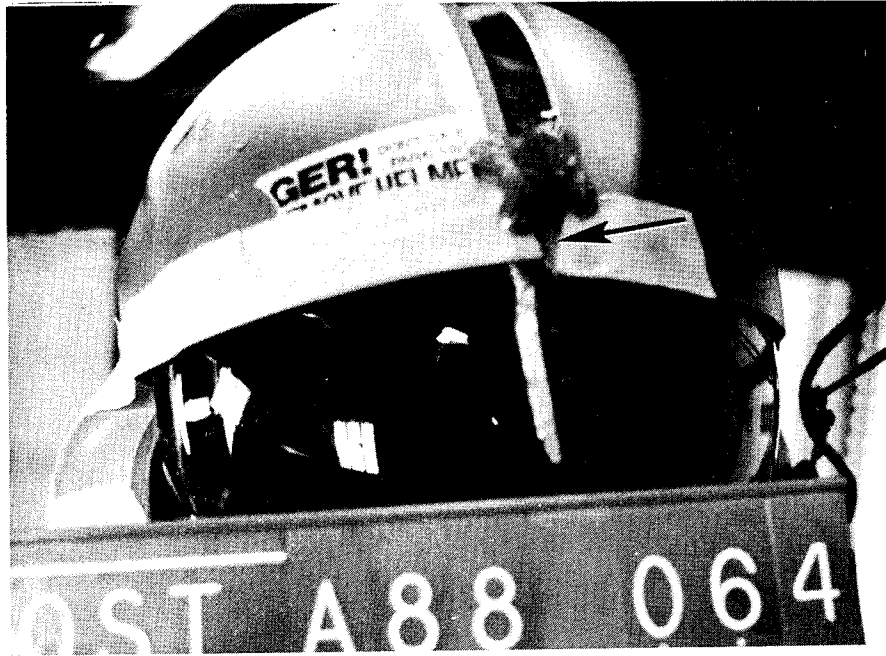
In spite of the damage to the mount and a fracture of the helmet visor cover, the neck force and moment values are less than those recorded in test 88061. Again, the neck transducers show a change in slope of the force and moment curves at approximately 105 ms, the time of the initial helmet impact, and the peak values were less than the prior test where the helmet did not impact the PDU. It is evident that helmet impact against the PDU tends to lower the force and moment in the neck caused by inertial force. Since the helmet prevents excessive head deceleration (from PDU impact), the PDU is not considered a hazard for helmeted pilots.

Figure 25. Posttest view of no. 88064; arrow denotes cracked helmet visor cover.

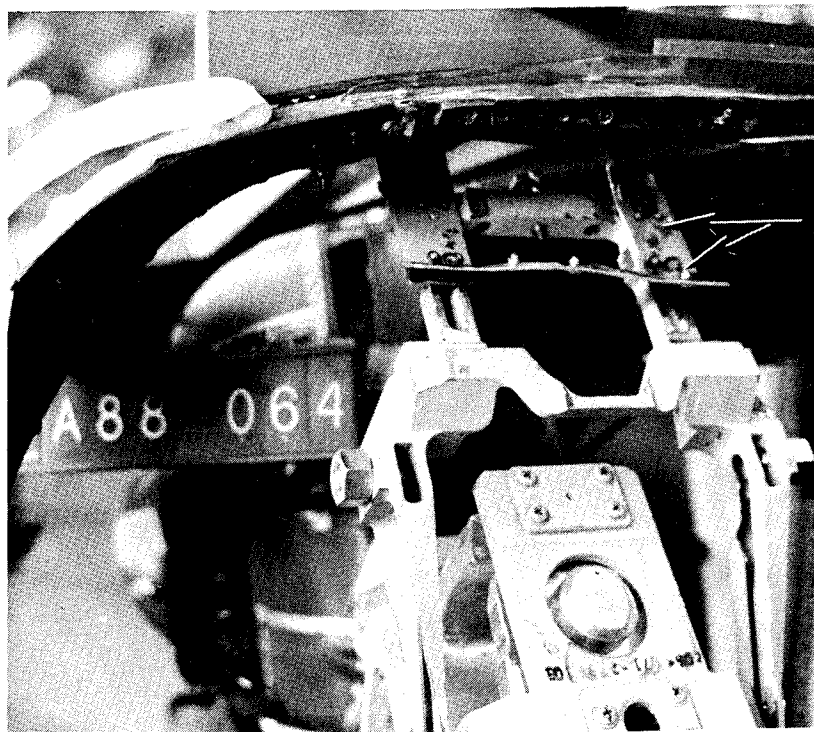
Figure 26. Posttest view of no. 88064; arrow denotes failed rivets which help to secure the PDU breakaway mount.
